Subject: MIL ON WITH DTC P0106	Bulletin No: 01-044/06
	Last Issued: 11/7/2006

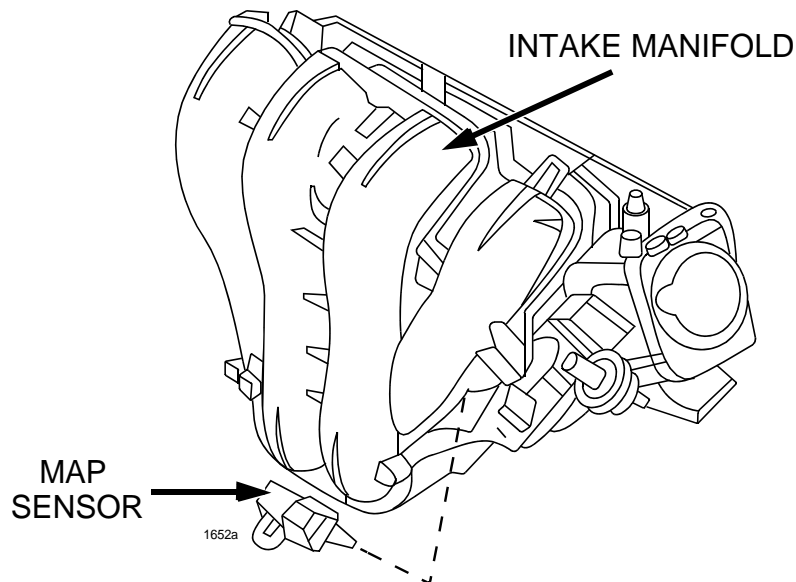
On some vehicles, the MIL may come on with DTC P0106 (MAP sensor malfunction) stored in memory due to corrosion of the MAP sensor chip. This produces a short circuit which causes the output characteristics of the MAP sensor to fall out of specification.

1. Verify customer concern.
2. Replace the MAP sensor with a modified one.
