Subject: CONDENSATION / FOG IN FRONT AND REAR COMBINATION LIGHTS	Bulletin No: 09-057/10
	Last Issued: 12/23/2010

2011 Mazda2	2012 Mazda5	2007-2011 Mazda CX-7
2004-2011 Mazda3	2003-2011 Mazda6	2007-2011 Mazda CX-9
2006-2010 Mazda5	2006-2011 Mazda MX-5	2004-2011 Mazda RX-8

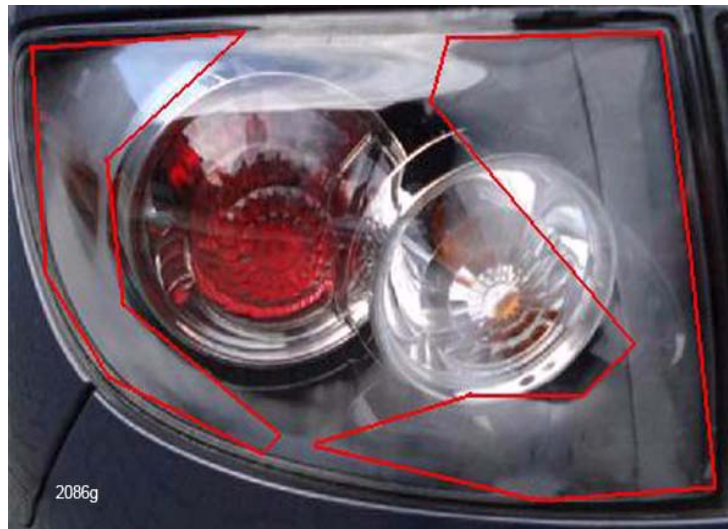
Examples of Light Units With Condensation/Fog That Should NOT Be Replaced

Condensation/fogging along the edges and in the corners is considered normal.

Explain to the customer that this is a natural phenomenon and not a quality defect. DO NOT attempt repairs as this is considered normal, and is NOT covered under Warranty. Replacing the light unit will not correct this symptom.

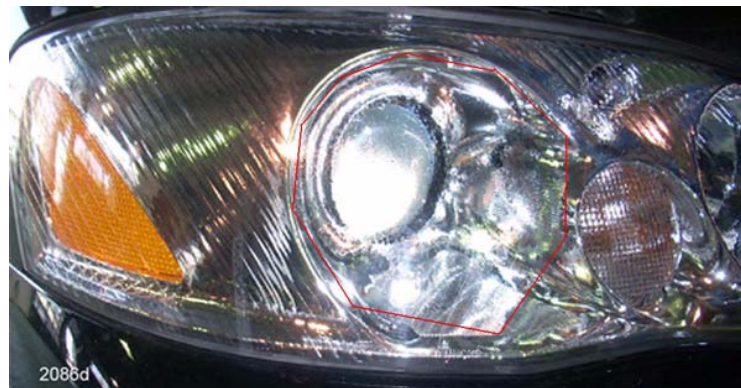
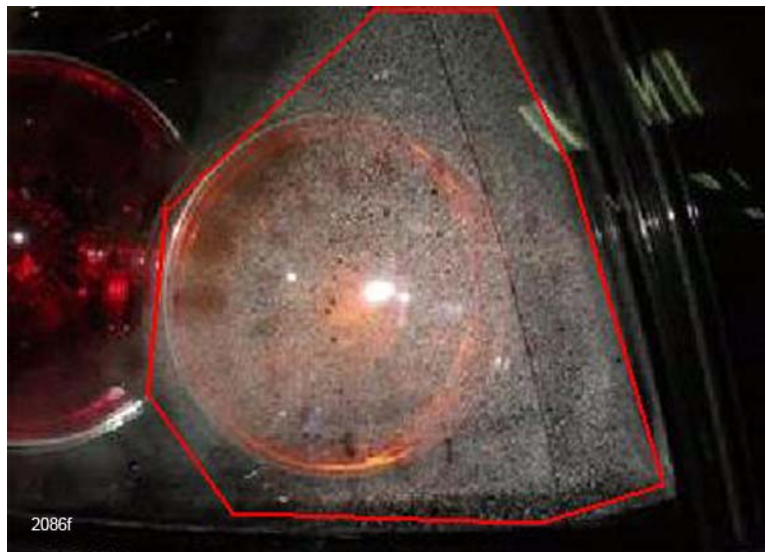
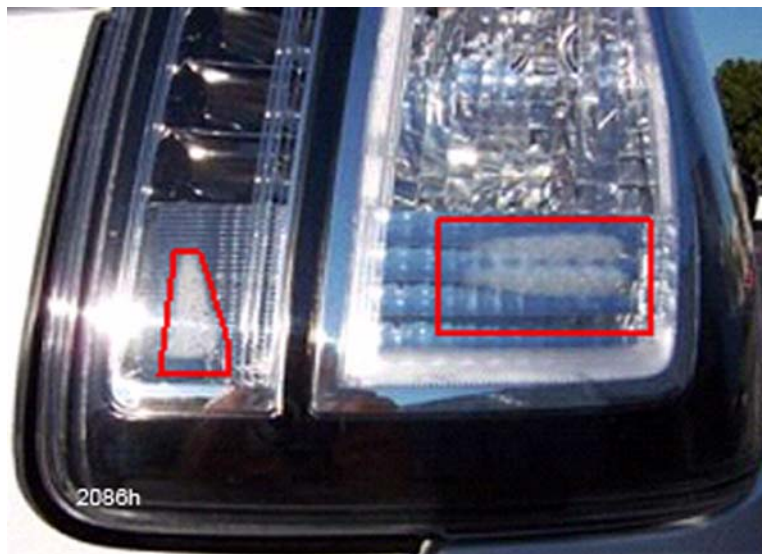
Some condensation/fogging on the lens is considered normal.

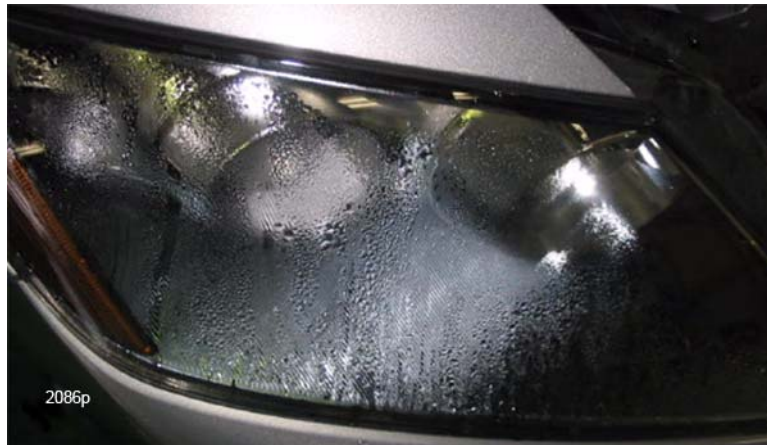
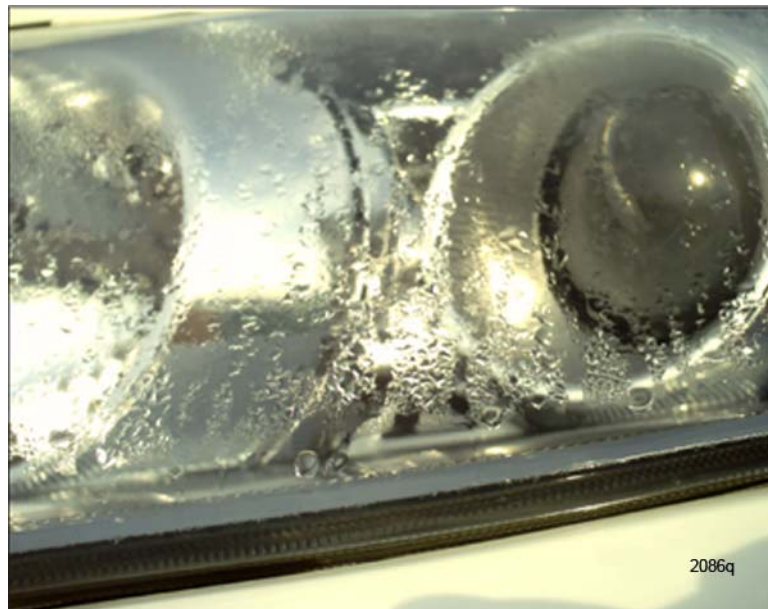
Examples of Light Units With Condensation/Fog That Should Be Replaced

Heavy/large amount of condensation on the lens is not normal.

- The location where the bulbs are fitted has a high air volume with good air circulation, therefore, if a large or heavy amount of condensation appears here, the light unit should be replaced. A small amount of condensation here is considered normal and should clear after the lights have been on for some time and the light unit should not be replaced. Refer to the following pictures for examples.
- If the outside conditions are unfavorable (cold and damp), even fog (dew concentration) as shown in the following pictures will take some time to clear up. Therefore, be careful in making a decision. A picture will be required with every claim for Warranty. If a light unit is found with no problem, and no picture is sent in, the claim may be later debited. You can also perform the following test to determine if the light unit should be replaced.

- If the condensation/fog clears, it is normal, and the light unit should not be replaced.
- If the condensation/fog does not clear, it is abnormal (water entry is suspected), and the light unit should be replaced.
