Subject: ACCESSORY CHROME FUEL DOOR WILL NOT OPEN	Bulletin No: 09-008/02
	Last Issued: 03/08/2002

1999 - 2002 Miata with accessory chrome fuel door

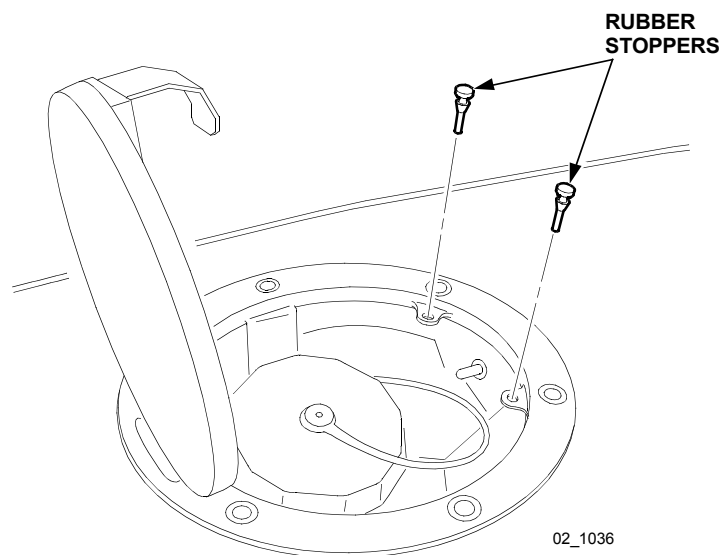
The accessory chrome fuel door may not open when the release lever is pulled from inside the vehicle's center console. This may be caused by the (2) rubber fuel door stoppers sticking to the underside of the fuel door. Follow the procedure outlined in this bulletin for installing revised rubber fuel door stoppers.

1. Verify customer concern.
2. Remove the (2) existing rubber stoppers from the fuel door.

3. Install (2) revised rubber stoppers pushing downwards.

NOTE: Make sure the stoppers are seated completely in the fuel door assembly.
