Subject: SEAT BELT COMES OUT OF SEAT BELT GUIDE WHEN RETRACTING	Bulletin No: 08-001/17
	Last Issued: 01/03/2017

2016 MX-5 vehicles with VINs lower than JM1ND*****108746 (produced before December 14, 2015)

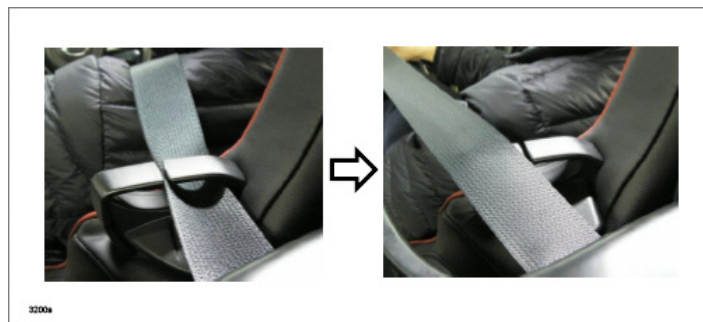
Some customers may complain that the seat belt comes out of the seat belt guide when the seat belt retracts as shown because the shape of the seat belt guide is inadequate.

1. Verify customer concern.
2. Remove two philips head screws on the seat belt guide, then replace the seat belt guide with a modified one (both sides).
3. Verify repair.

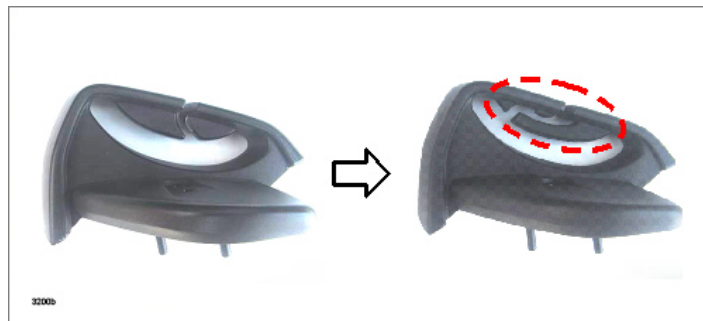
To correct the problem, the shape of the seat belt guide has been changed.
