| Subject: RATTLE NOISE FROM HEADER PANEL OF CONVERTIBLE TOP | Bulletin No: 09-045/15 |
| | Last Issued: 12/23/2015 |

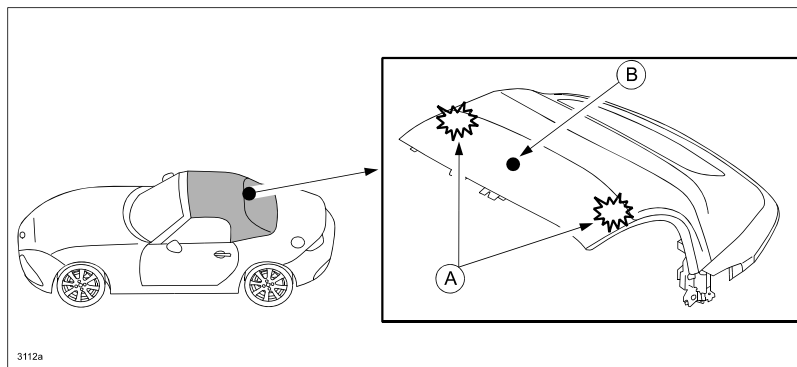
Some vehicles may exhibit a rattle noise (A) from the header panel (B) of the convertible top when driving on a rough road.

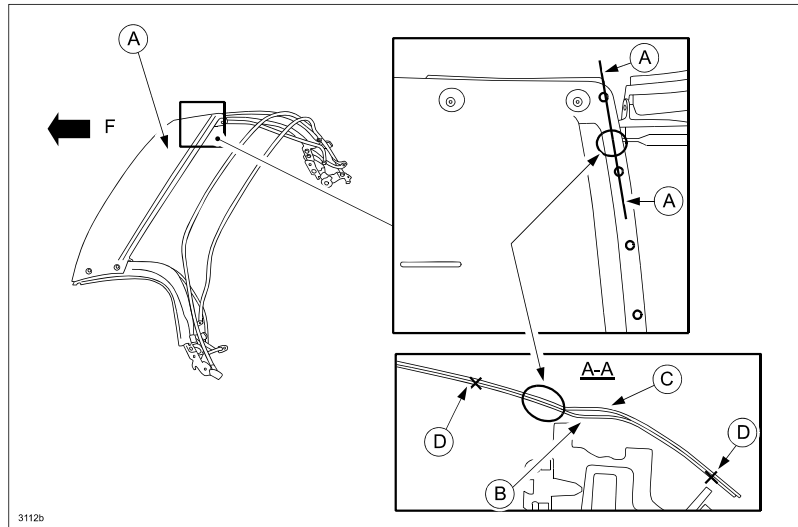
The header panel (A) is formed by two aluminum panels, inner (B) and outer (C). When receiving an input force by driving on a rough road, the two panels at the problem area, where spot welds are located (D), may warp and change relative position causing the rattling noise. (F=Front)
