Section <b>09</b>	Applicable Model/s <b>Multiple Models</b>	Subject <b>CIGARETTE LIGHTER DOES NOT WORK PROPERLY</b>	Bulletin No. <b>007/00</b>
			Issued <b>07/28/00</b>
			Revised

1997-2001 Protege, MPV, Miata, Millenia.

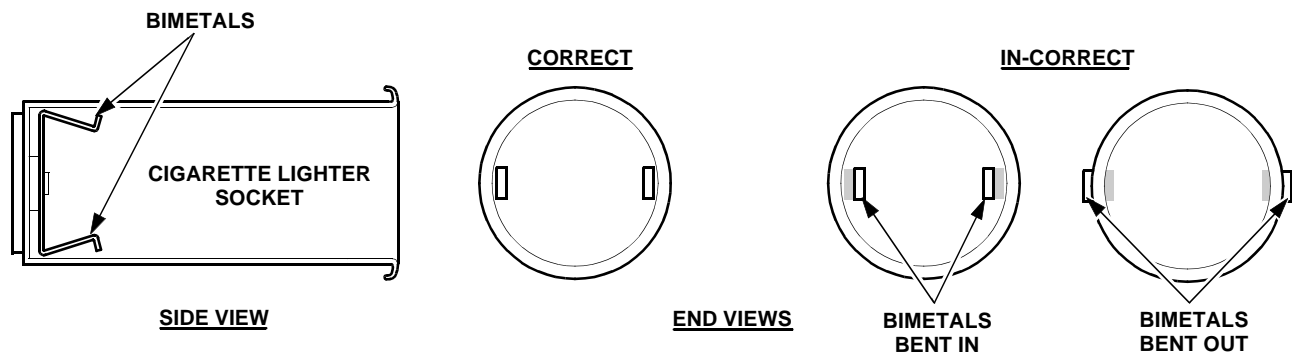
Some customers may state that their cigarette lighter does not work or stay in position. This concern can be caused by the use of an after-market cigarette lighter or a plug adapter of the wrong size for the cigarette lighter socket. As a result, the cigarette lighter socket bimetal can be bent as shown below and/or the socket retainer ring is broken.
