Section <b>01</b>	Applicable Model/s <b>1997-98 Protege 1996-97 Miata</b>	Subject <b>A/C INOPERATIVE / MIL "ON" DTC P0550</b>	Bulletin No. <b>011/99</b>
			Issued <b>04/19/99</b>
			Revised

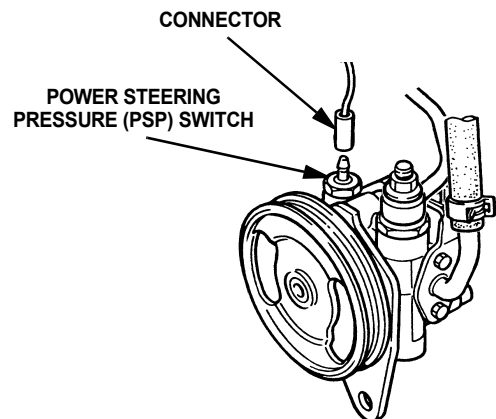
Some vehicles may exhibit the (A/C) system inoperative with the Malfunction Indicator lamp (MIL) ON. This may be due to the Power Steering Pressure (PSP) switch terminal assembly becoming corroded causing the Powertrain Control Module (PCM) to open the A/C relay circuit and set DTC P0550. A modified PSP switch terminal assembly is available to resolve this concern.

1. Verify customer concern.
2. Turn the A/C system ON and disconnect the PSP switch.
  - If the A/C system does not function, refer to the workshop manual for troubleshooting and repair information.
  - If the A/C system operates, replace only the PSP switch terminal assembly.
